Airtightness in Belgian high biocontainment facilities

**Overview of four BSL-3 facilities
and recommendations for optimal airtightness**

Biosafety and Biotechnology Unit

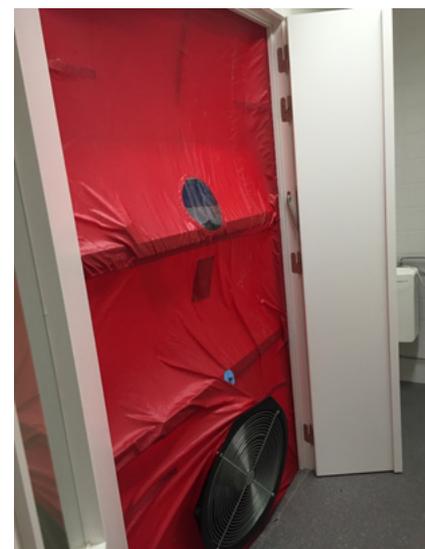
Figure 1: Blower-door with fan fitted in a lab door opening

The airtightness of a room can be quantified by means of a blower-door test (norm NBN EN 13829:2001), during which a pressure difference is created between the volume to be tested and the outside, by a calibrated fan that is hermetically fitted in a (door) opening (Figure 1). This fan (de)pressurizes the room for a multi-point test to a series of pressure differences up to $\sim 75 \text{ Pa}^4$ (measured by a calibrated manometer) and the required airflow to maintain a stable pressure difference is recorded. This is the leaked volume of air per hour, which is inversely proportional to the airtightness of the room. In order to effectively compare rooms of different sizes, the leaked volume of air per hour at the chosen pressure (V_{50}) is converted to the amount of air-changes per hour ($= n_{50}$ in unit h^{-1} in case of 50 Pa pressure difference), by normalizing against the total volume of the tested room.

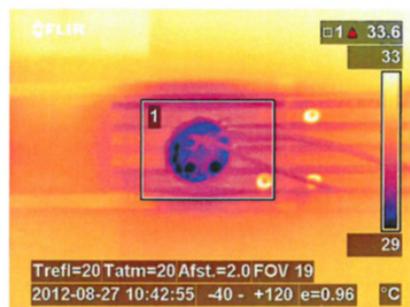
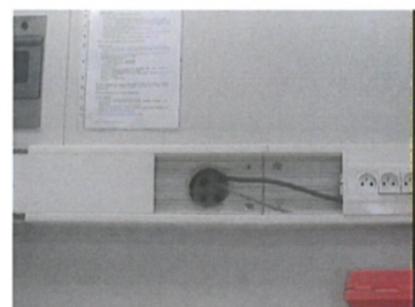
Figure 3: Thermal image (left) and white light image (right) of an electric fitting showing air leaks

The airtightness in this L3 facility was initially measured in three different operation modes: (1) with both the HVAC system and the double door autoclave sealed; (2) with a sealed HVAC system and the double door autoclave not sealed; (3) with both the HVAC system and the double door autoclave in standard working condition. In all instances the siphons were filled with water and in the present case, sealing off the autoclave meant it was completely covered with plastic foil, fastened to the wall; no distinction was made between sealing off the door and the connection between the autoclave body and the wall. The airtightness test revealed that the double door autoclave accounts for a total air leak of 13m³/h (difference between #2 and #1, table 2), and infrared imaging revealed further air leaks at perforations made in the walls to install the electrical outlets (Figure 3) and the emergency alarm box.

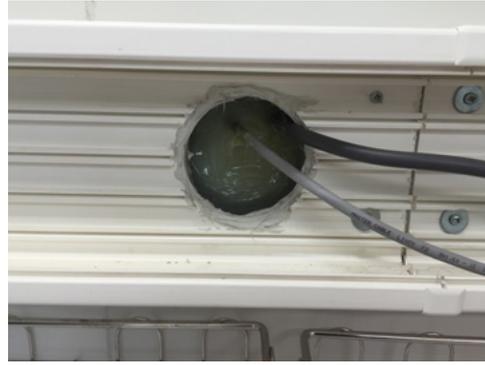
Figure 4: Injected silicone for the sealing of the perforation for electric cables

After attempting to fix the detected air leaks by application of silicone (Figure 4), the airtightness test was repeated twice separately one year later with the HVAC system and autoclave in normal operation mode. During the second and third tests air leaks were still observed at perforations in the containment barrier for the passage of cables.

Overall, the additional (second and third) airtightness tests did not indicate a significant gain in airtightness, suggesting that the initially detected leaks at the level of the wall perforations were not primarily responsible for the detected air losses or were not tackled well. A thorough analysis based on infrared imaging and air velocity measurements could be helpful to identify more air leaks, but is outside the scope of this project.

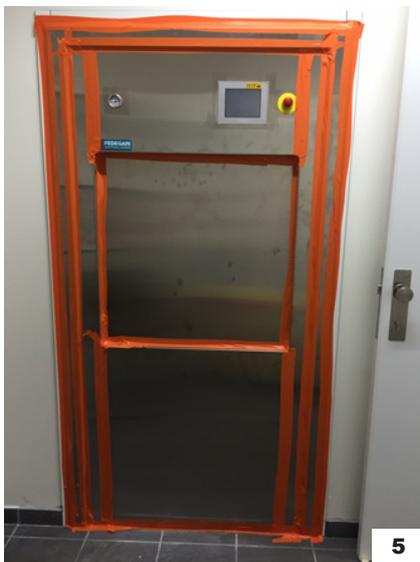
Figure 5: Double door autoclave sealed off with tape (table 4, #1)

To test the airtightness of both the autoclave and the room, blower-door tests were performed on two different days. Three tests were performed on day one: (1) with the autoclave's door and the junction between the autoclave frame and the wall sealed off (Figure 5); (2) with only the junction between the autoclave and the wall sealed; (3) with all sealing on the autoclave removed (operation mode) (table 3, #1, 2 and 3).
